INTERNATIONAL
chemco
PROTECTIVE COATINGS

TANK LININGS

Traditional & Solvent-free Systems

August 2018

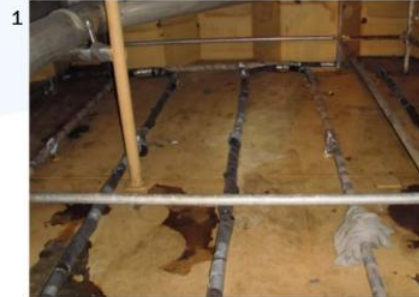
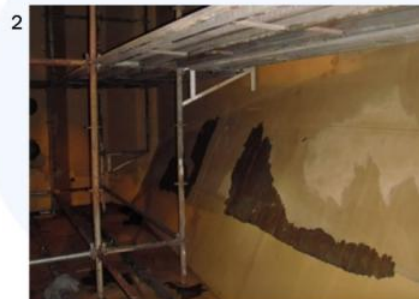
Complete failure of the previous lining as supplied by a major paint company had occurred; the usual phenolic epoxy specified and used would not have the resistance and had to be completely removed and a suitable coating applied; the new lining had to be resistant to most acids and alkaline chemicals at high temperature.

- Nos. 1-2 Original Condition of Cargo Tanks Before Preparation
- No. 3 Tank After First Coat of RB 364

Chemco's new specification was based on a unique chemical resistant coating suitable for full pH range at high temperature as follows:
 Surface preparation standard: Grit blast to Sa 2½
 Coating: Two coats of Chem-tect™ RB 364 @ 500µ
 DFT per coat plus one stripe coat of Chem-tect™ RB 364.
 Total DFT: Minimum 1,000µ

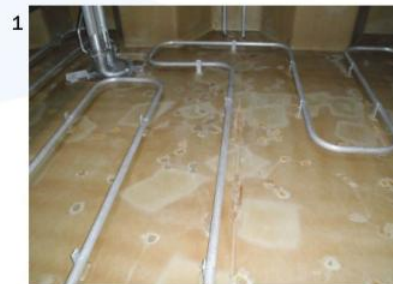
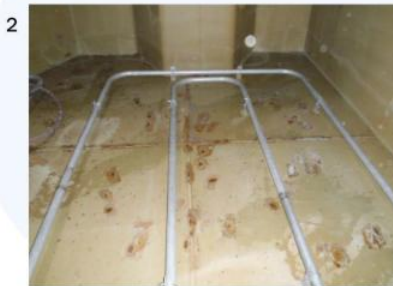
The tank tops found inside four cargo tanks (3 Port, 4 Port, 4 Starboard & 6 Port), onboard the Chemical Tanker, required a full refurbishment as they were showing signs of severe corrosion damage.

- Nos. 1-2 Original Condition
- No. 3 After First Coat of Chem-tect™ RB 364

The tank tops and the bulkheads (up to 0.5m high) were grit blasted to Sa 2.5 standards. Prior to the coating application, the surfaces were swept and vacuumed to remove any dust and other contamination.

- Two coats of Chem-tect™ RB 364 @ 500µ DFT per coat by airless spray.
- One stripe coat of Chem-tect™ RB 364 by brush.
- One topcoat of Chem-tect™ RB 300TC @ 100µ DFT by airless spray.

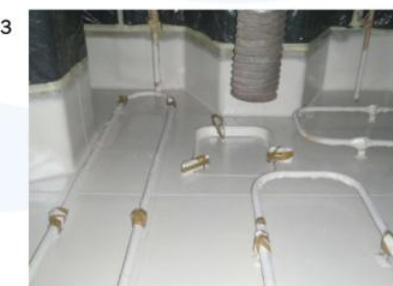
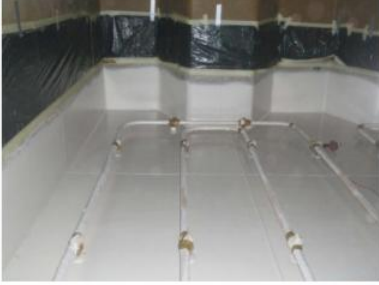
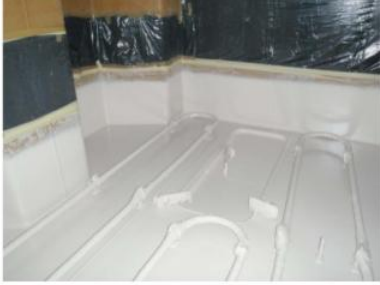
<p>Photographs:</p> <ul style="list-style-type: none">• No. 4 After First Coat of Chem-TECT™ RB 364• No. 5 After Second Coat of Chem-TECT™ RB 364• Nos. 6-9 Completed Application

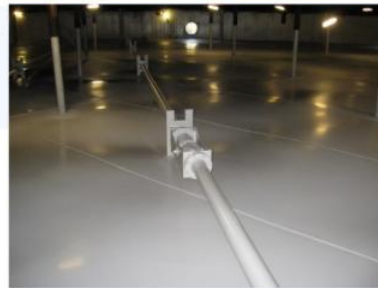
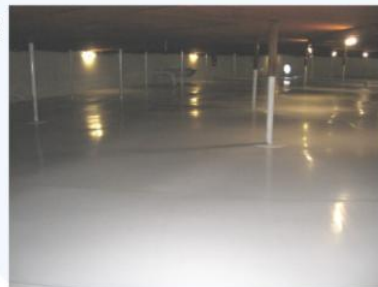
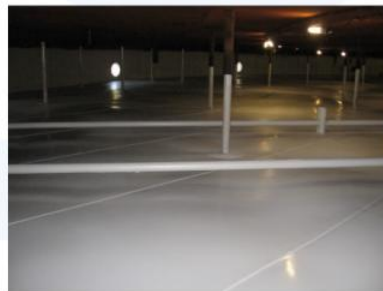
- Nos. 1 - 3 Crude oil tank after application

Two coats of Epo-chem™ RA 564 solvent-free, we tolerant glassflake epoxy @ 500µ per coat by airless spray with no requirement for ventilation or dehumidification.

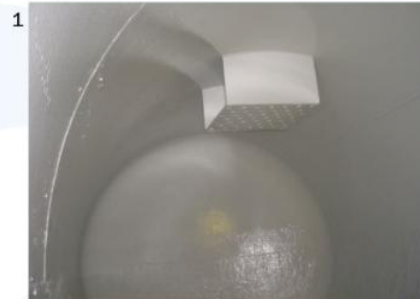
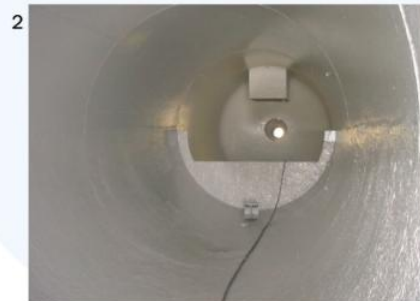
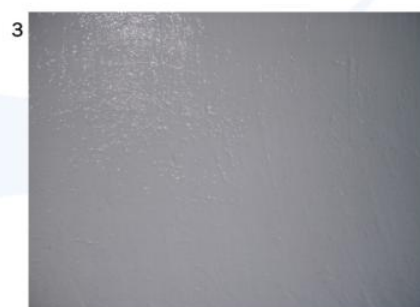
- Nos. 1 - 3 The process vessel after application

First coat of Epo-chem™ RA 564 solvent-free glassflake epoxy system @ 500µ DFT by airless spray. All deep pitting were filled with Ceram-chem™ RH 500 solvent-free, ceramic epoxy putty. Second coat of Epo-chem™ RA 564 solvent-free glassflake epoxy system @ 500µ by airless spray. Total DFT: 1,000µ

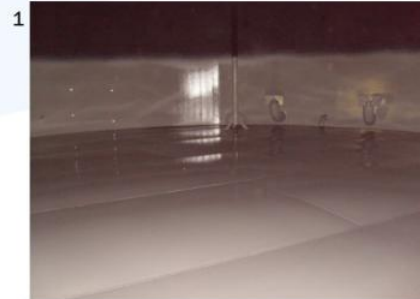
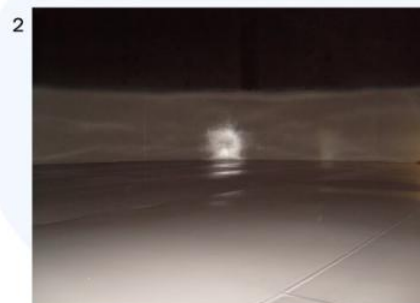
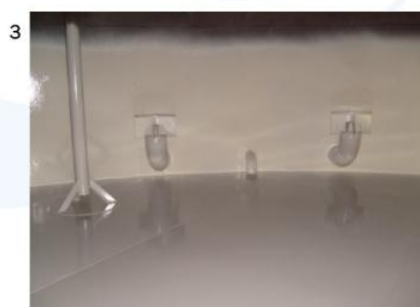
- Nos. 1-3 Application complete

First coat of Epo-chem™ RA 564 solvent-free glass-flake epoxy system @ 500µ DFT by airless spray. All deep pitting were filled with Ceram-chem™ RH 500 solvent-free, ceramic epoxy putty. Second coat of Epo-chem™ RA 564 solvent-free glassflake epoxy system @ 500µ by airless spray.
Total DFT: 1,000µ

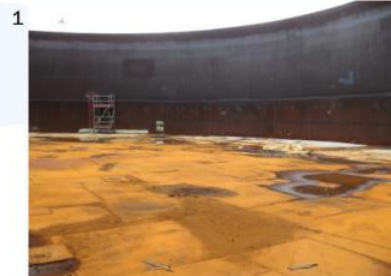
Tank internals suffer from heavy corrosion, pitting and severe metal loss. Combined with the possibility of holes, open-top tank exposed to elements, high humidity, cold and rain adding to the difficulty of this work.

- No. 1 Before application
- Nos. 2-4 Application in Progress

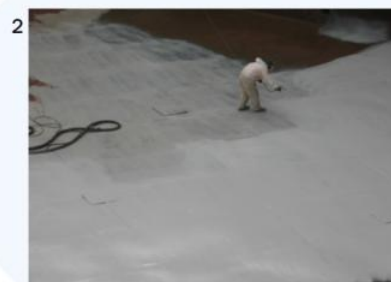
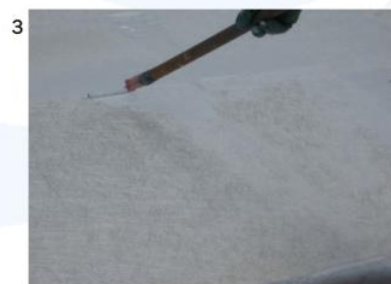
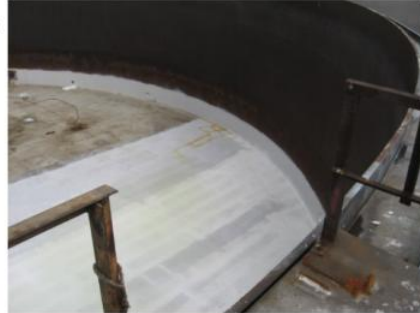
- No. 4 Application in Progress
- Nos. 5-6 Completed Application

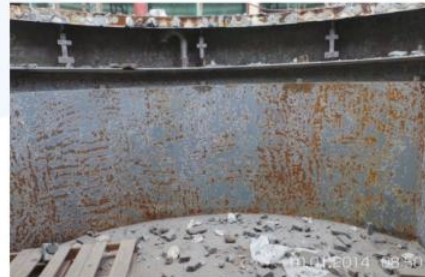
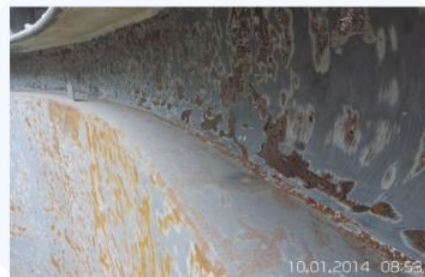
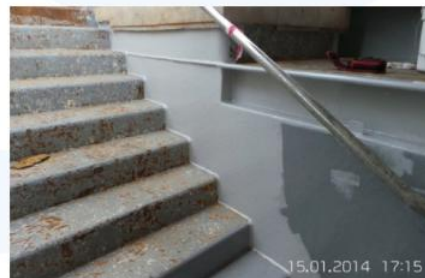
- Nos. 1-2 After Surface Preparation
- No. 3 Topcoat Being Applied on Top of Primer

Both mechanical preparation and water jetting were utilised as the surface preparation methods to St2 and WJ-3 standards respectively. Chemco's solvent-free, wet & rust tolerant primer Epo-chem™ RS 500P was applied followed by two coats of solvent-free, wet tolerant Epo-chem™ RA 500M.

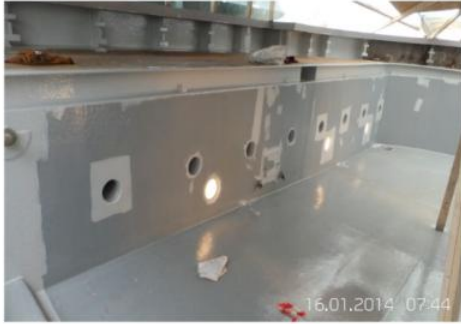
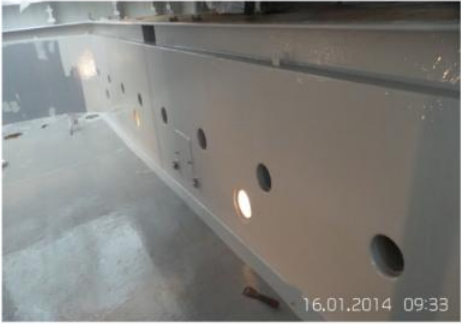
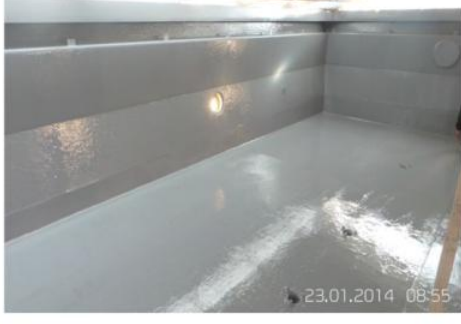
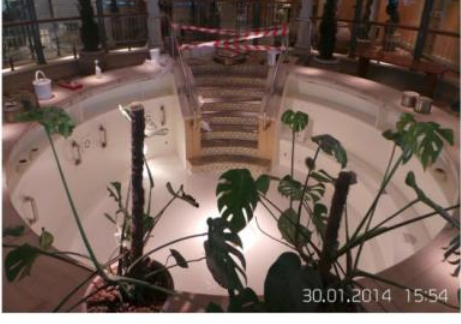
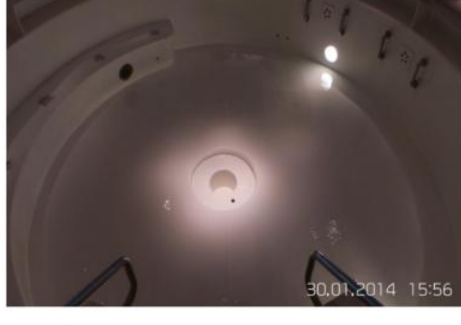
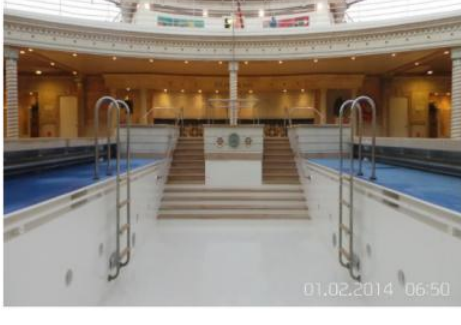
<p>01.02.2014 06:50</p> <p>Photographs</p> <ul style="list-style-type: none">• Nos. 4 and 5 First Topcoat Being Applied• No. 6 First Topcoat Complete• Nos. 7 - 9 Completed Application

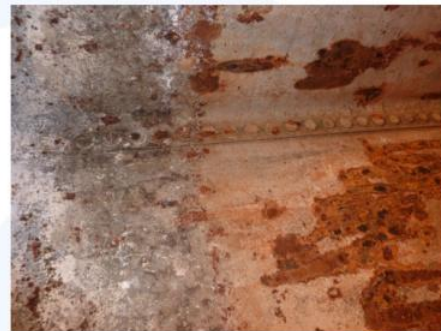
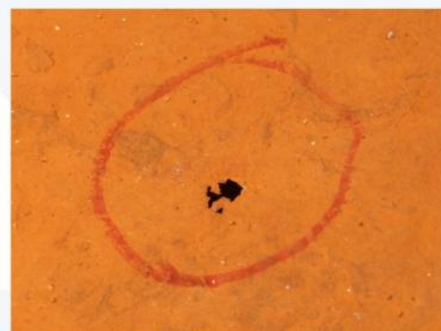
The potable water tanks were approximately 90 years old and were showing signs of corrosion damage. The client required these tanks to be restored to “as good as new” condition.

- Nos. 1 & 2 Before application

Manual preparation was selected as the surface preparation method. One primer coat of solvent-free, wet & rust tolerant Epo-chem™ RS 500P was applied first. This was followed by two topcoats of solvent-free, wet tolerant Epo-chem™ RA 500M.

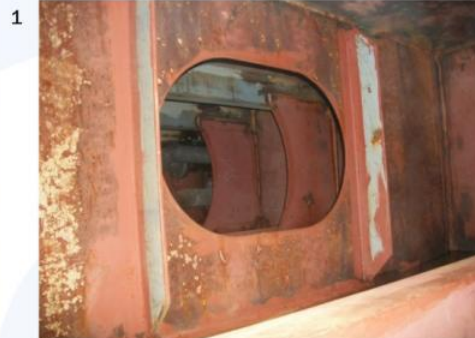
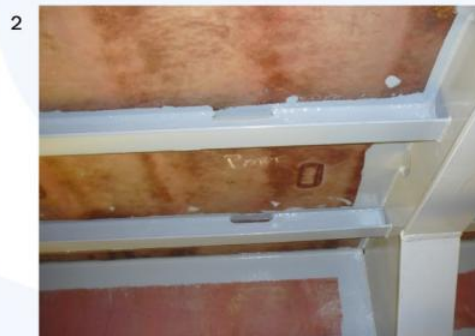
- No. 1 Before application
- No. 2 Stripe coating

Water jetting (500 bar) was utilised as the surface preparation method to remove any contaminants from the shop primed surfaces and the weld areas were mechanically prepared prior to the application of the IMO Approved Chemco System. One stripe coat of solvent-free, wet & rust tolerant Epo-chem™ RS 500P was then applied, followed by one full coat, both @ 100µ. To complete the system, one topcoat of solvent-free, wet tolerant Epo-chem™ RA 500M was applied @ 250µ.

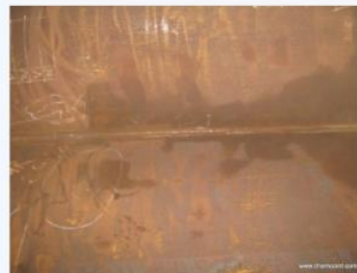
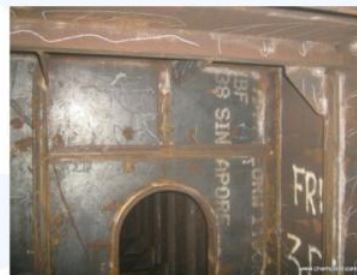
- No. 1 Talisman on station
- Nos. 2-3 Surfaces ready for coating

High pressure-wash (800 bar) to remove loose rust and loose mill scale. First/Primer coat and stripe coat was carried out with Epo-chem™ RS 500P solvent-free, wet & rust tolerant system @ 100µ DFT followed by the topcoat with Epo-chem™ RA 500M solvent-free, wet tolerant system @ 250µ DFT.

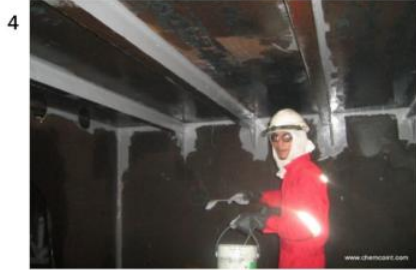
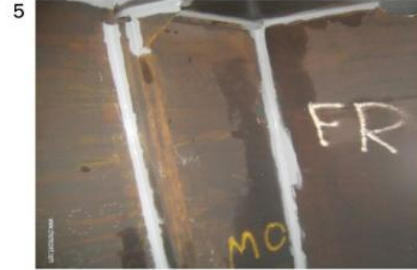
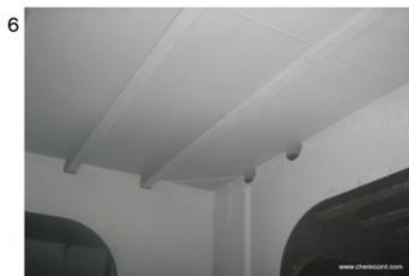
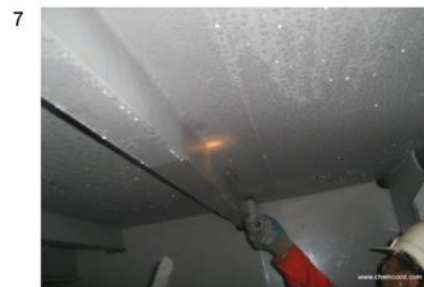
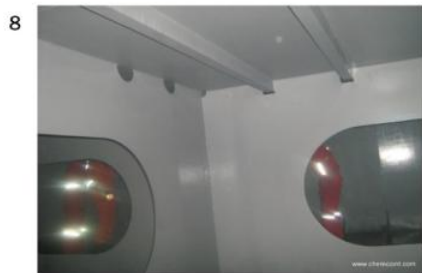
- Nos. 4-5 Stripe coating with RS 500P
- No. 6 Full coat RS 500P
- No. 7 RA 500M being applied on wet surface
- No. 8 Completed RA 500M topcoat

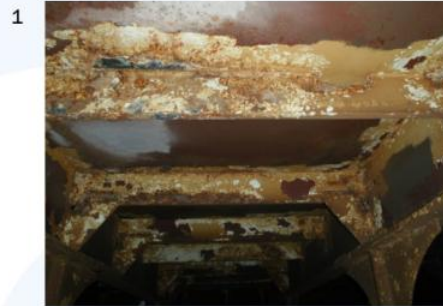
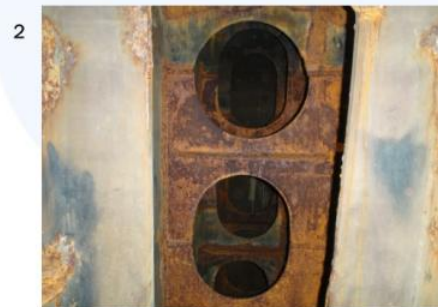
Some areas of the ballast tanks were heavily corroded with limited access. There was also a very limited time-scale for completion of this project and as a result, grit blasting was not permissible.

- No. 1 Deep tank before surface preparation
- No. 2 Wing tank before surface preparation

Utilise water jetting as the surface preparation method to WJ-3 standards. Apply one stripe coat of solvent-free, wet & rust tolerant epoxy Epo-chem™ RS 500P followed by one full coat of Epo-chem™ RS 500P @ 200µ DFT. In some localized areas, where most of the existing paint was still adherent, one primer coat of Epo-chem™ RS 500P in all the bare steel areas was applied, followed by one topcoat of solvent-free, wet tolerant epoxy Epo-chem RA 500M applied @ 250µ DFT.

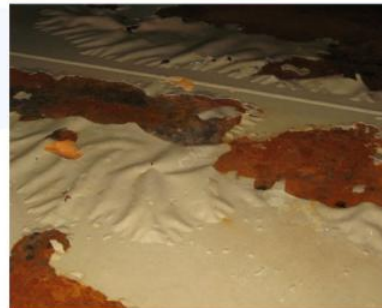
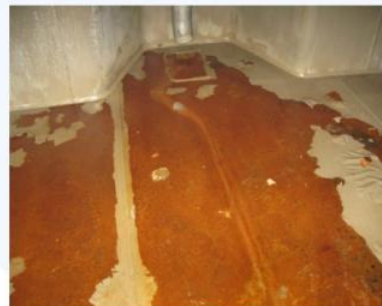
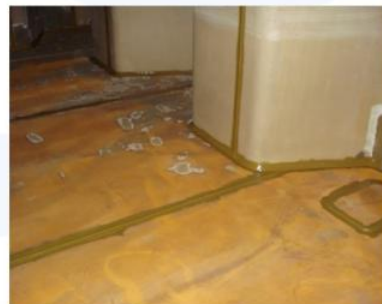
The chemical/oil carrier, built in 2011 and operated by Bernard Schulte Cyprus, had a requirement for a cargo tank refurbishment of 1200m² after the original coating (from new) had suffered failure.

- Nos. 1-2 Original Failed Condition of Existing Lining
- No. 3 Stripe Coat of Epo-chem™ RE 500P on the Rusty Surface

To achieve this challenge, water blasting was chosen as the alternative surface preparation method. Chemco's unique Epo-chem™ RE 500P and RW 500 were specified as the preferred coating system. Epo-chem™ RE 500P is a solvent-free, surface (rust tolerant) epoxy Novolac primer and RW 500 is a solvent-free epoxy Novolac glassflake topcoat. The original coating was removed by high pressure water jetting to achieve a WJ-2 standard. The following specification was applied:

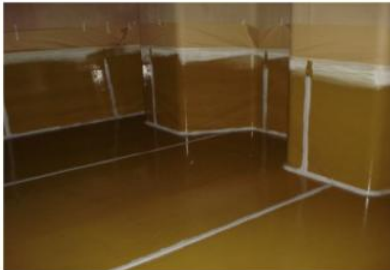
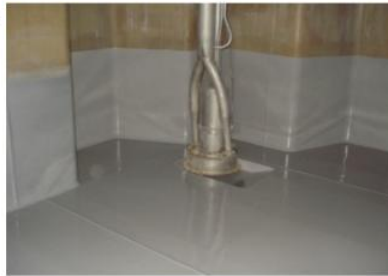
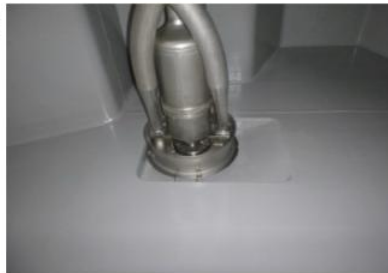
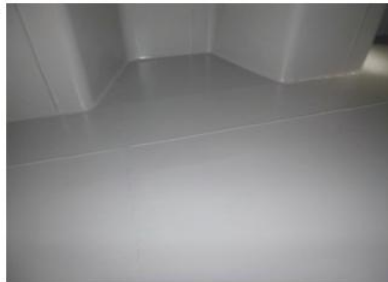
- No. 4 Stripe Coat of Epo-chem™ RW 500 on Primed Surface of Epo-chem™ RE 500P
- No. 5 Contrast Between Finished Application of Epo-chem™ RW 500 and Original Surface
- No. 6 COT 2 Starboard After Carrying Ethanol for 14 days
- No. 7 COT 5 Port After Carrying Ethanol for 14 days

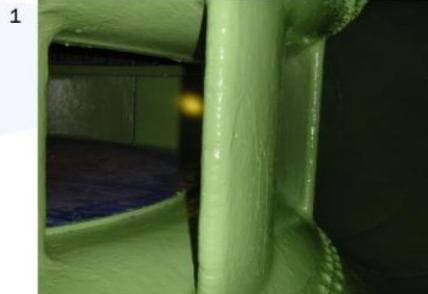
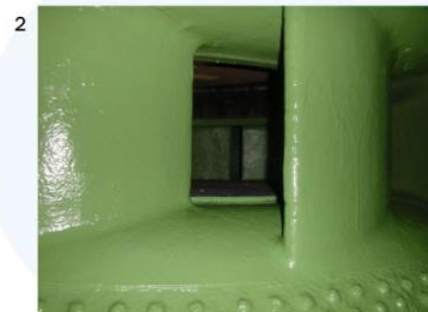
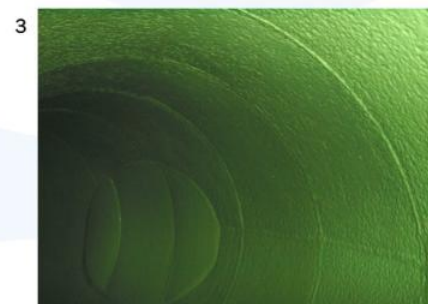
Working within a very tight timescale, severe pitting and corrosion, extremely high humidity, confined space, water ingress and other contractors working adjacent to the spiral refurbishment added to the difficulty of the project.

- Nos. 1-3 Spiral Casing After Application
