REPORT

TANK LININGS

Traditional & Solvent-free Systems

August 2018

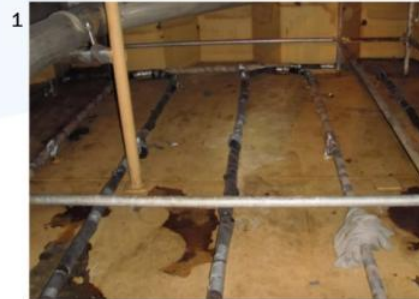
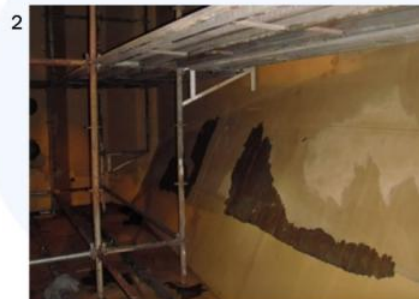
Complete failure of the previous lining as supplied by a major paint company had occurred; the usual phenolic epoxy specified and used would not have the resistance and had to be completely removed and a suitable coating applied; the new lining had to be resistant to most acids and alkaline chemicals at high temperature.

- Nos. 1-2 Original Condition of Cargo Tanks Before Preparation
- No. 3 Tank After First Coat of RB 364

Chemco's new specification was based on a unique chemical resistant coating suitable for full pH range at high temperature as follows:
 Surface preparation standard: Grit blast to Sa 2½
 Coating: Two coats of Chem-tect™ RB 364 @ 500µ
 DFT per coat plus one stripe coat of Chem-tect™ RB 364.
 Total DFT: Minimum 1,000µ

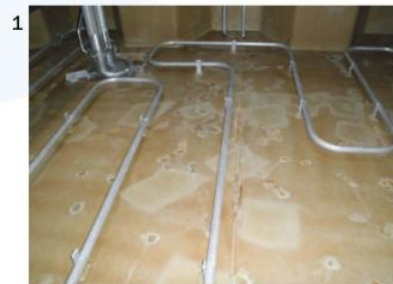
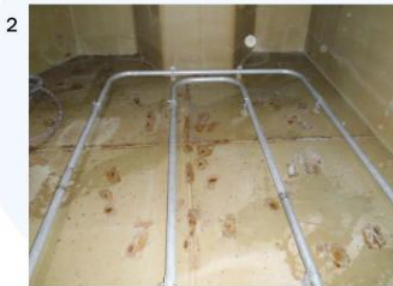
The tank tops found inside four cargo tanks (3 Port, 4 Port, 4 Starboard & 6 Port), onboard the Chemical Tanker, required a full refurbishment as they were showing signs of severe corrosion damage.

- Nos. 1-2 Original Condition
- No. 3 After First Coat of Chem-tect™ RB 364

- Two coats of Chem-tect™ RB 364 @ 500µ DFT per coat by airless spray.
- One stripe coat of Chem-tect™ RB 364 by brush.
- One topcoat of Chem-tect™ RB 300TC @ 100µ DFT by airless spray.

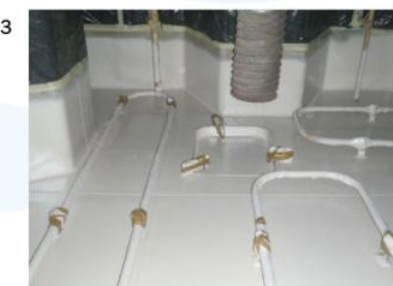
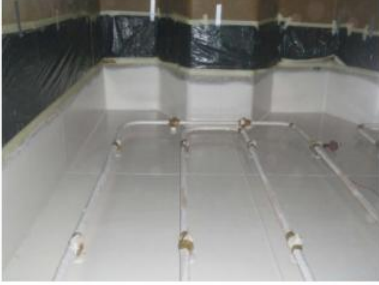
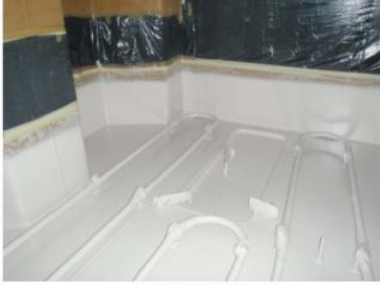
<p>Photographs:</p> <ul style="list-style-type: none">• No. 4 After First Coat of Chem-TECT™ RB 364• No. 5 After Second Coat of Chem-TECT™ RB 364• Nos. 6-9 Completed Application

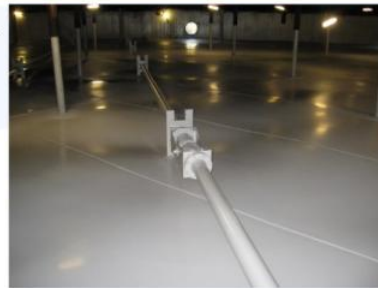
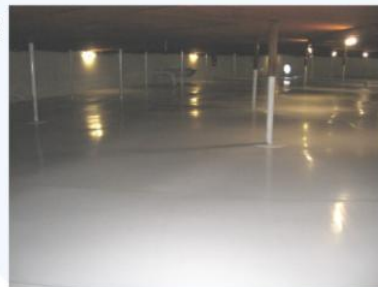
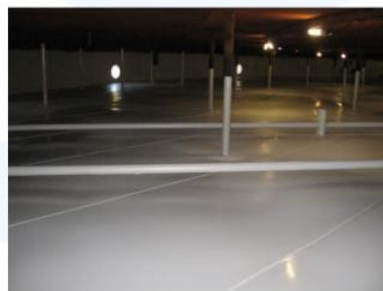
- Nos. 1 - 3 Crude oil tank after application

Two coats of Epo-chem™ RA 564 solvent-free, we tolerant glassflake epoxy @ 500µ per coat by airless spray with no requirement for ventilation or dehumidification.

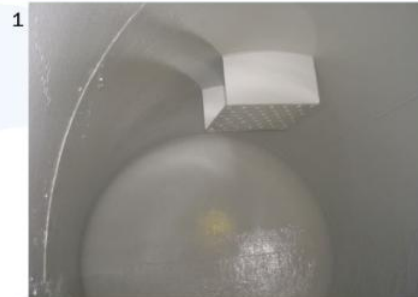
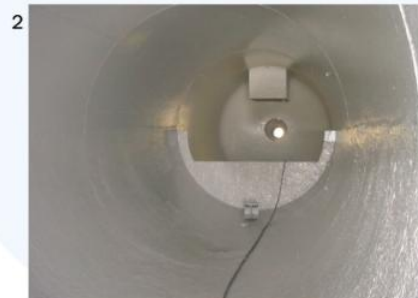
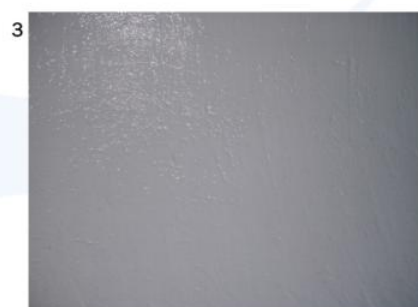
- Nos. 1 - 3 The process vessel after application

First coat of Epo-chem™ RA 564 solvent-free glassflake epoxy system @ 500µ DFT by airless spray. All deep pitting were filled with Ceram-chem™ RH 500 solvent-free, ceramic epoxy putty. Second coat of Epo-chem™ RA 564 solvent-free glassflake epoxy system @ 500µ by airless spray. Total DFT: 1,000µ

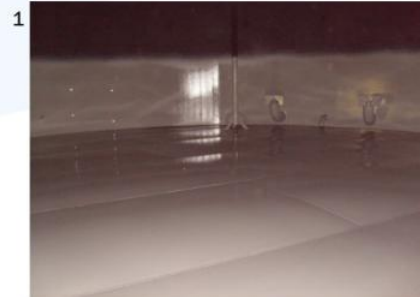
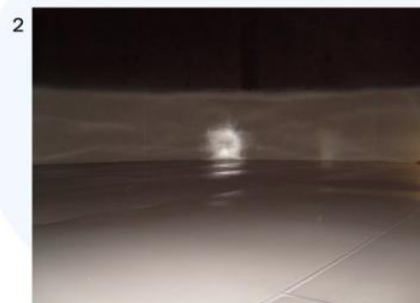
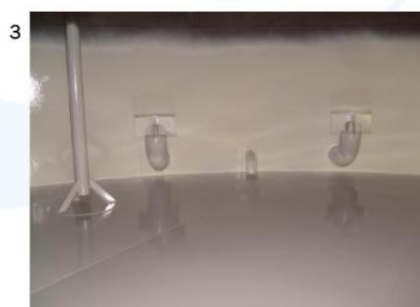
- Nos. 1-3 Application complete

First coat of Epo-chem™ RA 564 solvent-free glass-flake epoxy system @ 500µ DFT by airless spray. All deep pitting were filled with Ceram-chem™ RH 500 solvent-free, ceramic epoxy putty. Second coat of Epo-chem™ RA 564 solvent-free glassflake epoxy system @ 500µ by airless spray.
Total DFT: 1,000µ

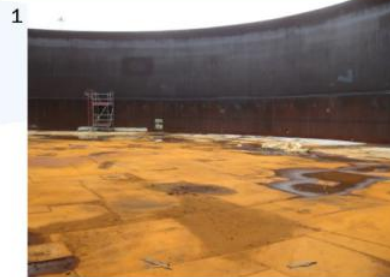
Tank internals suffer from heavy corrosion, pitting and severe metal loss. Combined with the possibility of holes, open-top tank exposed to elements, high humidity, cold and rain adding to the difficulty of this work.

- No. 1 Before application
- Nos. 2-4 Application in Progress

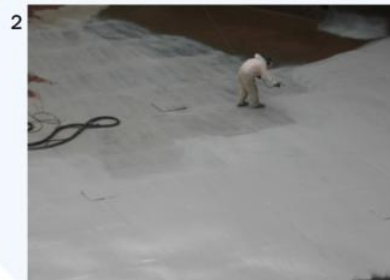
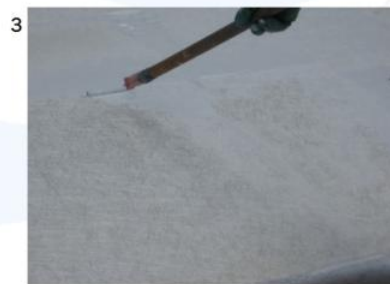
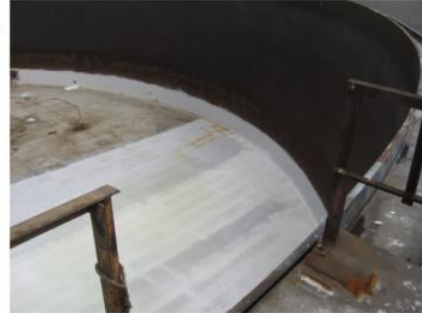
- No. 4 Application in Progress
- Nos. 5-6 Completed Application

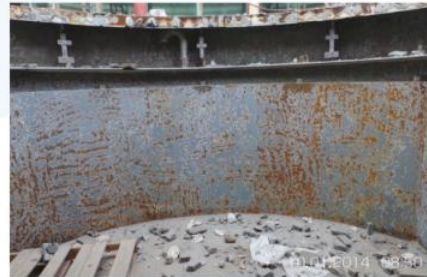
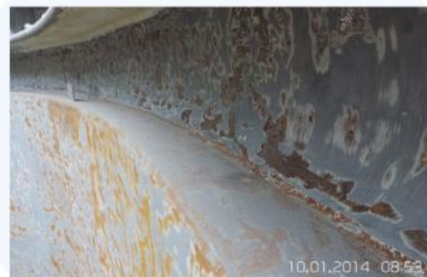
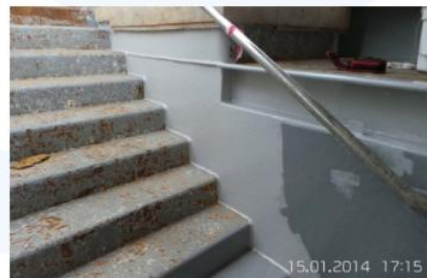
- Nos. 1-2 After Surface Preparation
- No. 3 Topcoat Being Applied on Top of Primer

Both mechanical preparation and water jetting were utilised as the surface preparation methods to St2 and WJ-3 standards respectively. Chemco's solvent-free, wet & rust tolerant primer Epo-chem™ RS 500P was applied followed by two coats of solvent-free, wet tolerant Epo-chem™ RA 500M.

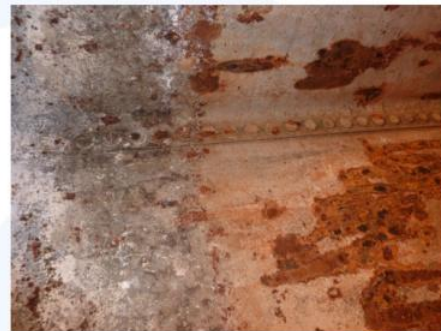
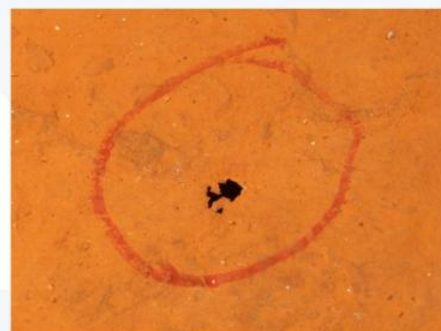
The potable water tanks were approximately 90 years old and were showing signs of corrosion damage. The client required these tanks to be restored to “as good as new” condition.

- Nos. 1 & 2 Before application

Manual preparation was selected as the surface preparation method. One primer coat of solvent-free, wet & rust tolerant Epo-chem™ RS 500P was applied first. This was followed by two topcoats of solvent-free, wet tolerant Epo-chem™ RA 500M.

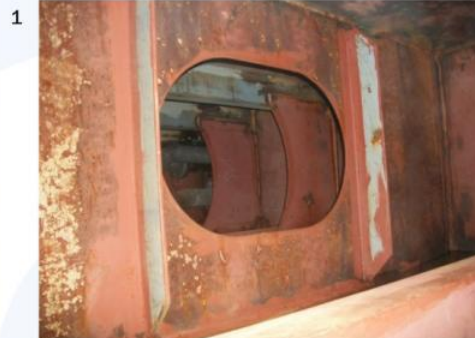
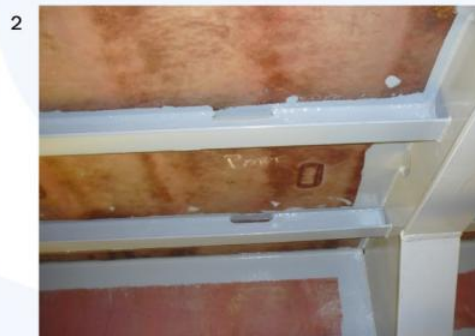
- No. 1 Before application
- No. 2 Stripe coating

Water jetting (500 bar) was utilised as the surface preparation method to remove any contaminants from the shop primed surfaces and the weld areas were mechanically prepared prior to the application of the IMO Approved Chemco System. One stripe coat of solvent-free, wet & rust tolerant Epo-chem™ RS 500P was then applied, followed by one full coat, both @ 100µ. To complete the system, one topcoat of solvent-free, wet tolerant Epo-chem™ RA 500M was applied @ 250µ.

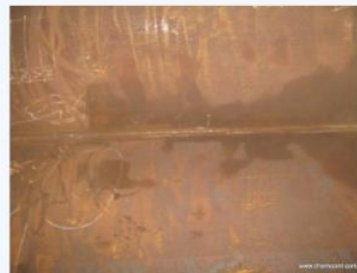
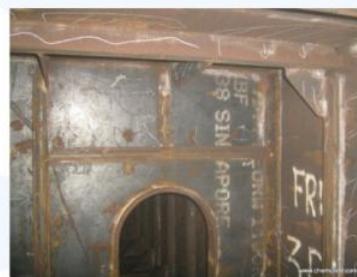
- No. 1 Talisman on station
- Nos. 2-3 Surfaces ready for coating

High pressure-wash (800 bar) to remove loose rust and loose mill scale. First/Primer coat and stripe coat was carried out with Epo-chem™ RS 500P solvent-free, wet & rust tolerant system @ 100µ DFT followed by the topcoat with Epo-chem™ RA 500M solvent-free, wet tolerant system @ 250µ DFT.

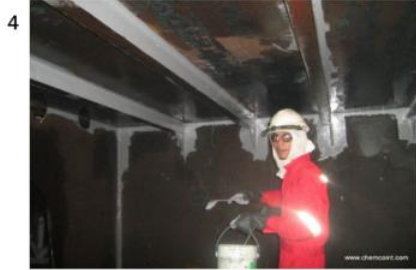
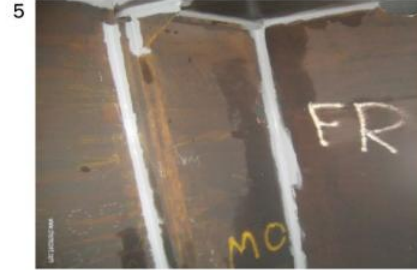
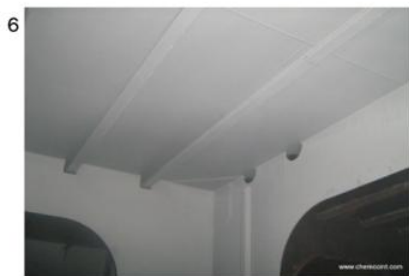
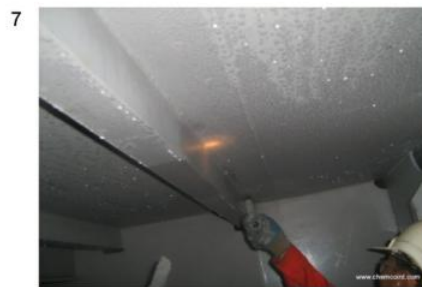
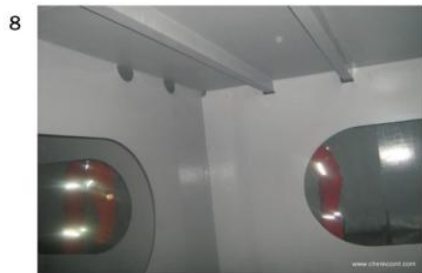
- Nos. 4-5 Stripe coating with RS 500P
- No. 6 Full coat RS 500P
- No. 7 RA 500M being applied on wet surface
- No. 8 Completed RA 500M topcoat

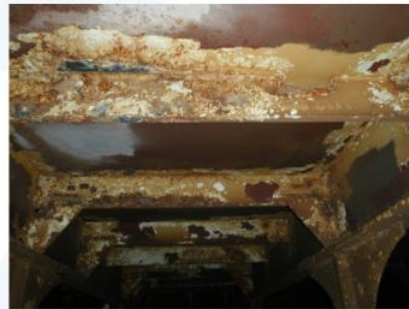
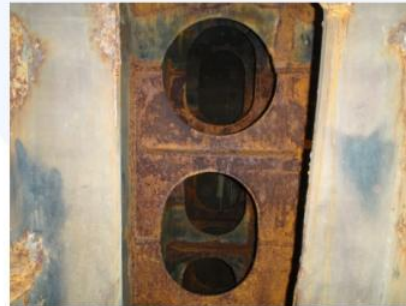
Some areas of the ballast tanks were heavily corroded with limited access. There was also a very limited time-scale for completion of this project and as a result, grit blasting was not permissible.

- No. 1 Deep tank before surface preparation
- No. 2 Wing tank before surface preparation

Utilise water jetting as the surface preparation method to WJ-3 standards. Apply one stripe coat of solvent-free, wet & rust tolerant epoxy Epo-chem™ RS 500P followed by one full coat of Epo-chem™ RS 500P @ 200µ DFT. In some localized areas, where most of the existing paint was still adherent, one primer coat of Epo-chem™ RS 500P in all the bare steel areas was applied, followed by one topcoat of solvent-free, wet tolerant epoxy Epo-chem RA 500M applied @ 250µ DFT.

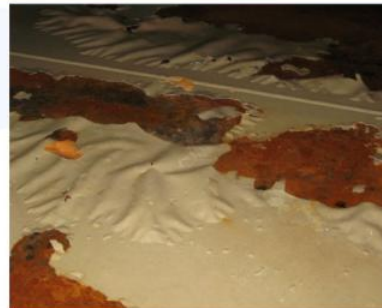
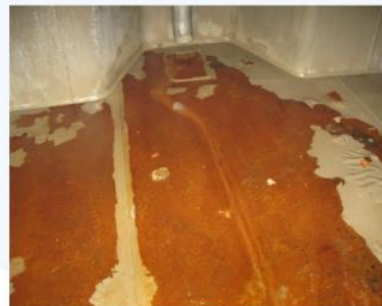
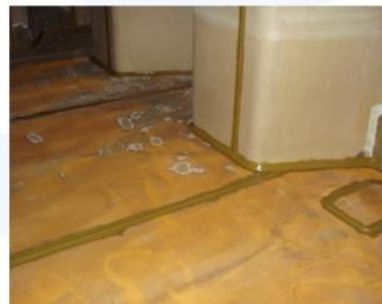
The chemical/oil carrier, built in 2011 and operated by Bernard Schulte Cyprus, had a requirement for a cargo tank refurbishment of 1200m² after the original coating (from new) had suffered failure.

- Nos. 1-2 Original Failed Condition of Existing Lining
- No. 3 Stripe Coat of Epo-chem™ RE 500P on the Rusty Surface

To achieve this challenge, water blasting was chosen as the alternative surface preparation method. Chemco's unique Epo-chem™ RE 500P and RW 500 were specified as the preferred coating system. Epo-chem™ RE 500P is a solvent-free, surface (rust tolerant) epoxy Novolac primer and RW 500 is a solvent-free epoxy Novolac glassflake topcoat. The original coating was removed by high pressure water jetting to achieve a WJ-2 standard. The following specification was applied:

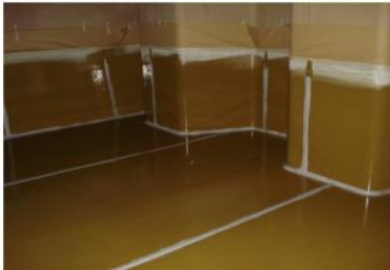
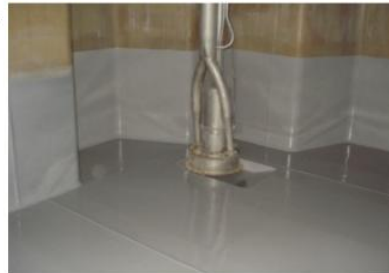
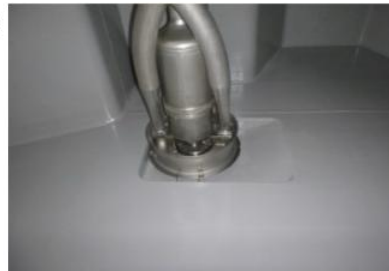
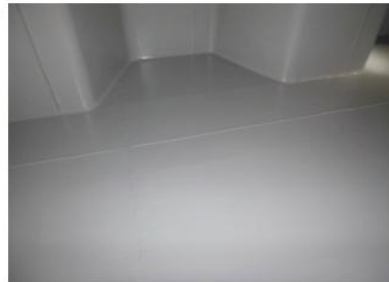
- No. 4 Stripe Coat of Epo-chem™ RW 500 on Primed Surface of Epo-chem™ RE 500P
- No. 5 Contrast Between Finished Application of Epo-chem™ RW 500 and Original Surface
- No. 6 COT 2 Starboard After Carrying Ethanol for 14 days
- No. 7 COT 5 Port After Carrying Ethanol for 14 days

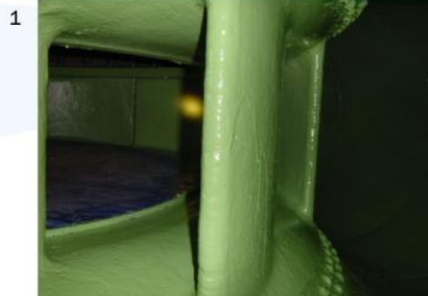
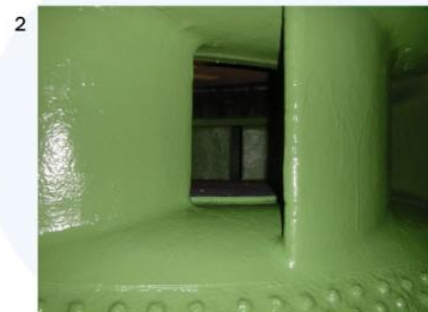
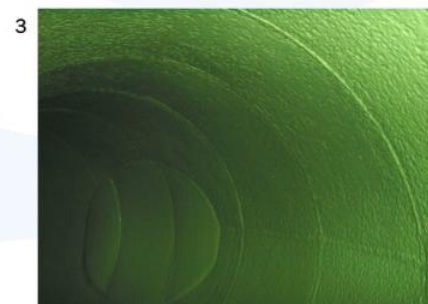
Working within a very tight timescale, severe pitting and corrosion, extremely high humidity, confined space, water ingress and other contractors working adjacent to the spiral refurbishment added to the difficulty of the project.

- Nos. 1-3 Spiral Casing After Application
